Manhole Inspection Summary

Manhole # S47K__016MH

Insp Date: **4/1/08 3:54 PM**

Location Address: **2114 S Fleet St**

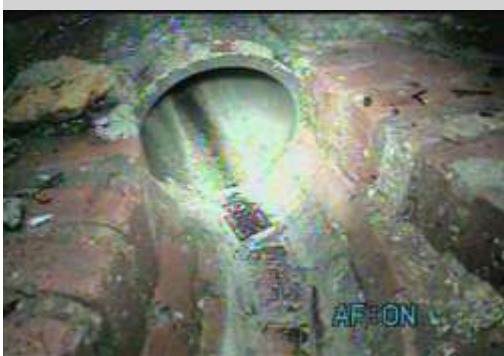
Miscellaneous

Bench Debris

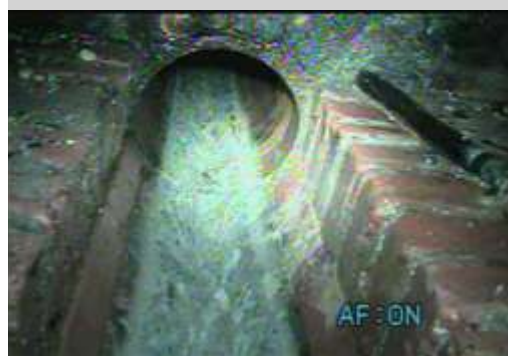
Defect 2

Infiltration: ☐ None ☐ Joint ☐ Cracks ☐ Mortar ☐ Roots ☒ **Wall**

barrel infiltration above pipe In @ 6

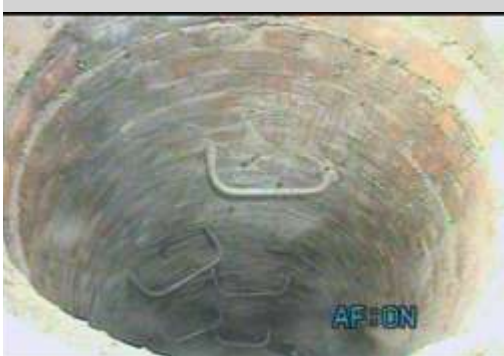
Defect 1

Infiltration: ☐ None ☒ **Joint** ☐ Cracks ☐ Mortar ☐ Roots ☐ Wall

☒ **Corroded**

corroded stairs, joint infiltration

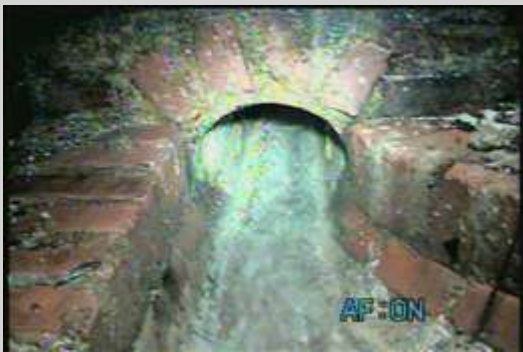
12 O'Clock Outflow

8 in. Circular Gravity Sewer
Pipe Out @ 12 O'Clock

Invert Depth: **10.82** (ft.) Flow Characteristics: **Fast**

Infiltration: **None** Pipe Seal Cond: **Unknown**

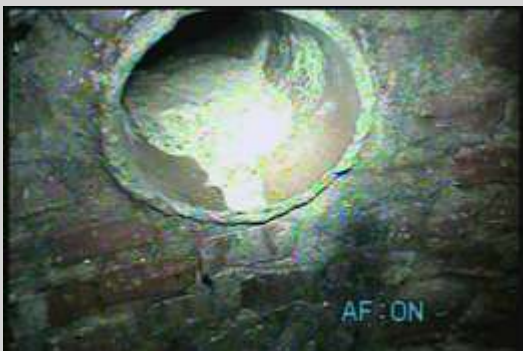
3 O'Clock Inflow

8 in. Circular Gravity Sewer
Pipe In @ 3 O'Clock

Invert Depth: **7.84** (ft.) Flow Characteristics: **Fast**

Infiltration: **None** Pipe Seal Cond: **Unknown**

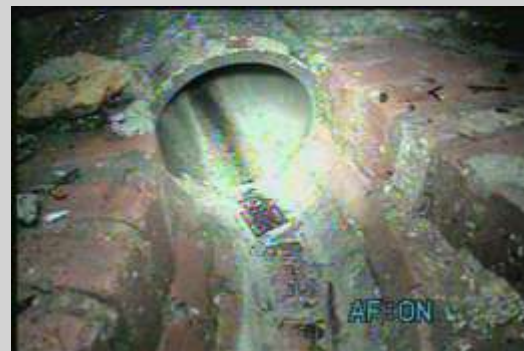
Drop In @ 3 O'Clock

Drop: **Outside Direct**

Inv Depth: **10.21** (ft.)

Drop Condition: **Open**

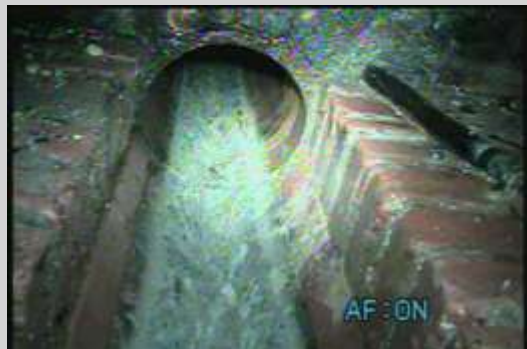
6 O'Clock Inflow

8 in. Circular Gravity Sewer
Pipe In @ 6 O'Clock

Invert Depth: **10.05** (ft.) Flow Characteristics: **Fast**

Infiltration: **None** Pipe Seal Cond: **Unknown**
